Earthquake damage on the vaulted nave of the Atlatlahucan Ex-Convent church in Morelos, Mexico

Abstract. The State of Morelos, in Mexico, has an architectural heritage conformed by 4614 religious and civil buildings, many of which were severely affected by the earthquake that occurred on September 19, 2017, which also caused damages to the built heritage in the states of Puebla, Tlaxcala, Mexico and Mexico City. A total of about 2800 heritage buildings suffered different damages degrees, reaching in many cases the collapse of elements such as vaults, domes, bell towers as well as their cloisters. The Ex-Convent of San Mateo in Atlatlahucan, Morelos, suffered damages on its main nave, in the pinnacles on the longitudinal side walls as well as in the clock box located on the front façade. In the present work, an analysis is made of the damages observed in the building, as well as a preliminary analytical diagnosis of the behavior of the main nave in order to propose future reinforcement actions for the building.

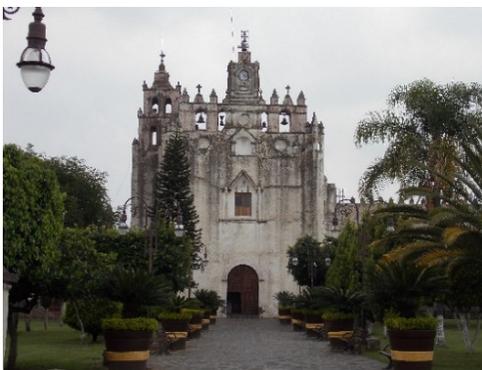
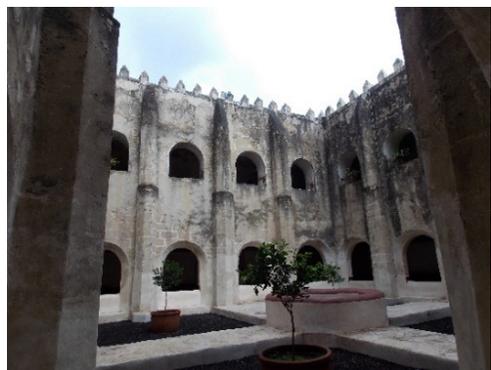
Fig. 1. a) Main façade and b) cloister of the Atlatlahucan Ex-Convent before September 19, 2017, earthquake

The Ex-Convent of San Mateo, Atlatlahucan, was begun in 1535 and completed in 1567 and is part of the eleven convents that integrate the well-known route of the convents. This building was recognized in 1994 by UNESCO as cultural heritage of the humanity (Fig. 1). On September 19, 2017 at 13:14:40 local time, a 7.1 magnitude earthquake occurred with an epicenter of coordinates 18.4 North latitude and -98.72 West longitude and a hypocentral depth of 57 km, according to data from the Institute of Geophysics of the Autonomous National University of Mexico, UNAM, (Fig. 2). The earthquake had a seismogenic mechanism of “normal or traction” faulting produced by the Cocos plate subducted below the North American plate, as shown in the focal mechanism of Fig. 2. The mentioned fault consists in the rupture by traction of the subducted plate at intermediate depths (50-60 Km), occurring in most cases within the earth’s crust (which is why they are also known as “intraplate” earthquakes) and at short distances from urban centres.

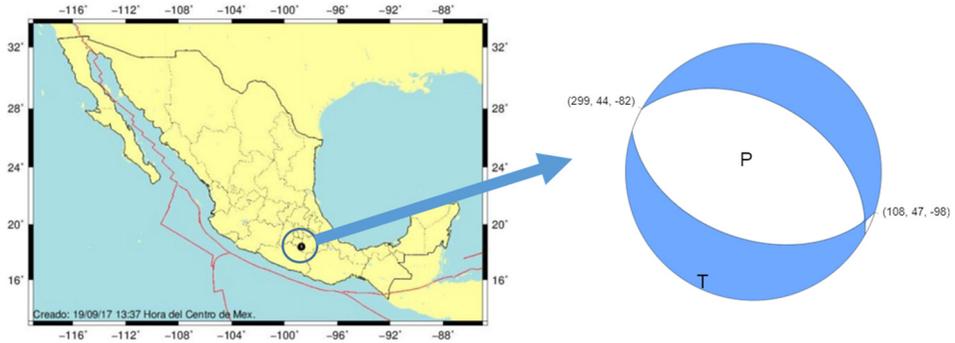
Fig. 2. a) Epicenter location and b) focal mechanism obtained by the USGS of the September 19, 2017, earthquake

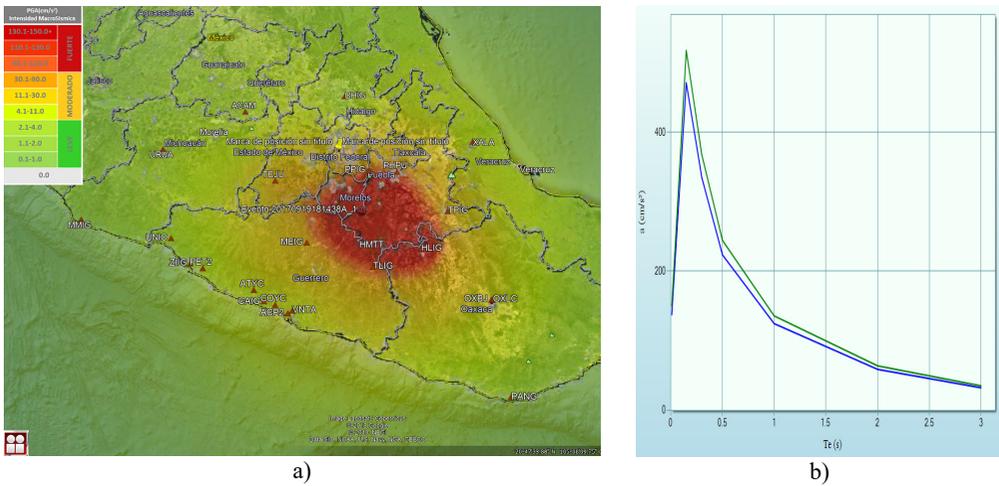
Fig. 3. a) Intensities map performed by the Engineering Institute of the UNAM and b) uniform seismic hazard spectrum on stiff soil

Intensities map performed by the Engineering Institute of the UNAM, shows peak ground

accelerations of 130.1 to 150 cm/s^2 , maximum value that according to the site seismic hazard corresponds to the return period of 457.2 years (Fig. 3(a)), value that can be observed on the $T_e(s)$ equal to zero ordinate in the uniform seismic hazard spectrum (Fig. 3(b)), calculated on stiff soil [1].

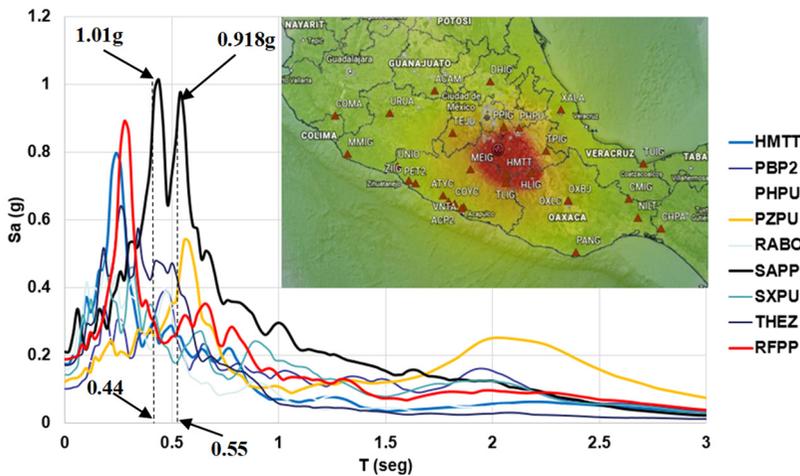
Fig. 4. Response spectra of the nine seismic stations nearest to the building

Fig. 4 shows the response spectra of the seismic stations located near to the Ex convent, where it can be seen that the highest spectral amplifications of the acceleration occurred in a range of periods of vibration from 0.18 to 0.54 seconds, reaching a maximum value of 1.01 g associated to a 0.44 s vibration period.

floor of the cloister (Fig. 7) with the purpose of obtain the fundamental vibration period for the site, and on the other hand in an approximate way, a structural analysis of the main nave macroelement was performed using elastic finite elements and considering the highest pseudo-acceleration record, that is, the one corresponding to the SAPP seismic station (Fig. 4).

The hypocentral distances to the SAPP station and the Atlatlahuca Ex Convent were 107 km and 85 km respectively, so the spectral pseudoacceleration for the site 0.55 seconds ground period was at least of 918 cm/s^2 (Fig. 4). The two-dimensional finite element model was built using the geometric characteristics (Fig. 9) published by other authors [3], and was calibrated iterating the Young's Module until the fundamental period of the nave numerical model was equal to the obtained with the following formula [4]:

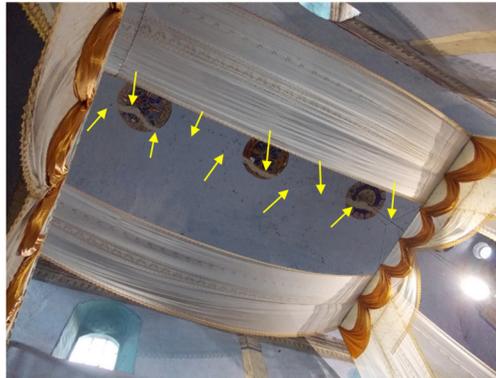
Prior to the September 19, 2017 earthquake the barrel vault of the temple had a longitudinal crack in the intrados of the arch key, which seems to be recently been consolidated at the date of the picture (Fig. 5). After the seismic event, the probable consolidation with a high strength material produced the appearance of a system of two additional longitudinal cracks both sides of the original crack (Fig. 6), which evidences the fact that the application of materials with higher strength than the original can lead the appearance of additional damages that can generate unstable rigid blocks.

Fig. 5. Existing longitudinal crack recently consolidated (picture taken on September 21, 2016)

The structural analysis of the nave considering only its selfweight shows that in the intrados of the key, from its origin, tension stresses were already present with a value of 0.408 MPa (Fig. 10(b)), which partly explains the observed crack in Fig. 5, and which had been previously repaired. This traction stress was produced by the horizontal thrust forces whose effect can be seen in the deformed shape that was amplified for visualization purposes (Fig. 10(a)). It is shown that the maximum lateral displacement produced by the thrust was of almost half a millimeter (0.04 cm), enough to produce cracking due to the practically zero traction resistance of the ancient masonry.

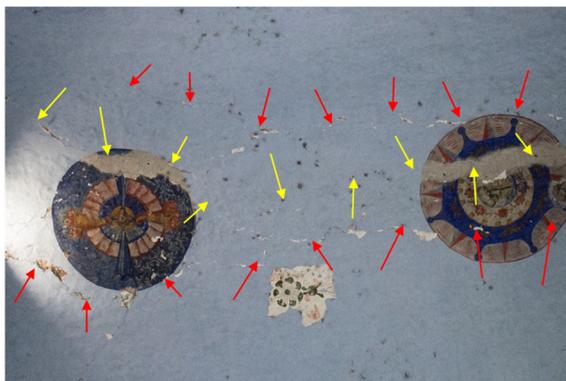
Fig. 6. Longitudinal cracks on the intrados of the main vault. The original crack (yellow arrows) and the new ones following the previous one at both sides (red arrows) are shown

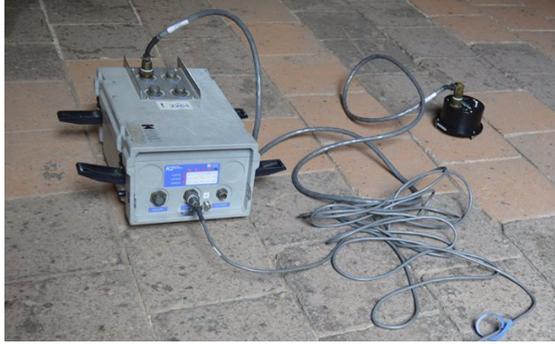
Fig. 7. Ambient vibration measurements on the cloister ground level

For the ambient vibration measurements performed on the cloister ground level a 24 bits K2 acquisition console and a triaxial ES-T sensor (Fig. 7) were used, both from the Kinemetrics brand. Two 10-minute acceleration measurements were taken at 200 samples per second, which were processed in the frequency domain to subsequently apply the H/V ratio technique [2]. With the above, a frequency of 1.81 Hz was obtained (Fig. 8) which is equivalent to a vibration period of 0.55 seconds, a value which is within the spectral range of maximum pseudoacceleration amplitudes (Fig. 4).

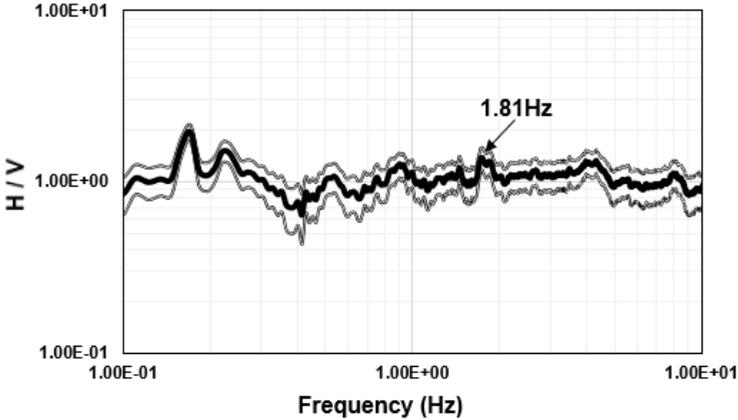
Fig. 8. H/V relationship on the cloister ground level

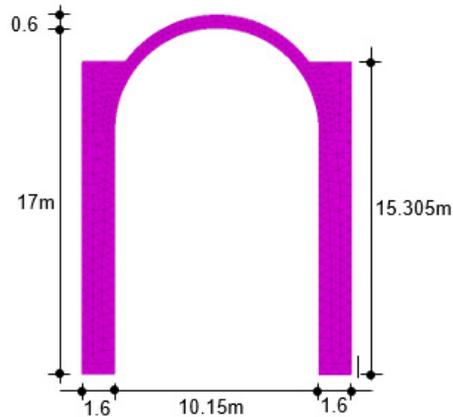
Fig. 9. FE mesh and transversal macroelement geometry for the Atlatlahucan nave

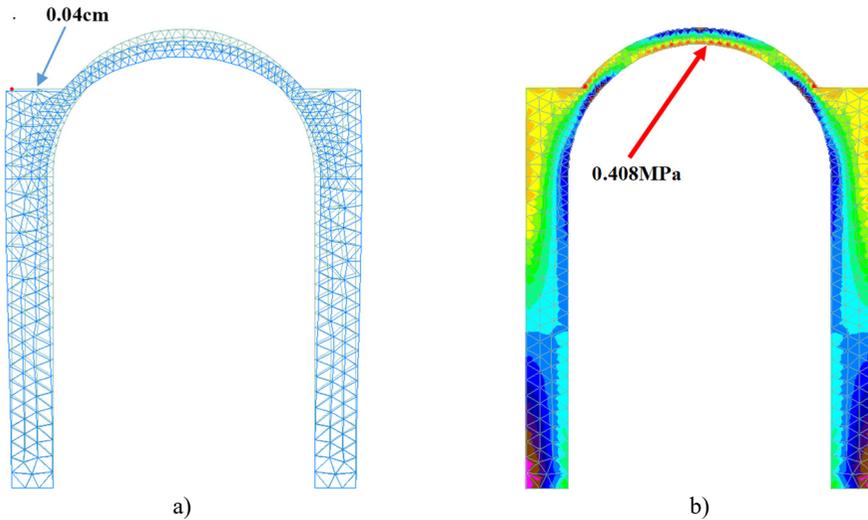
Fig. 10. Elastic displacements and principal stresses for the selfweight load condition

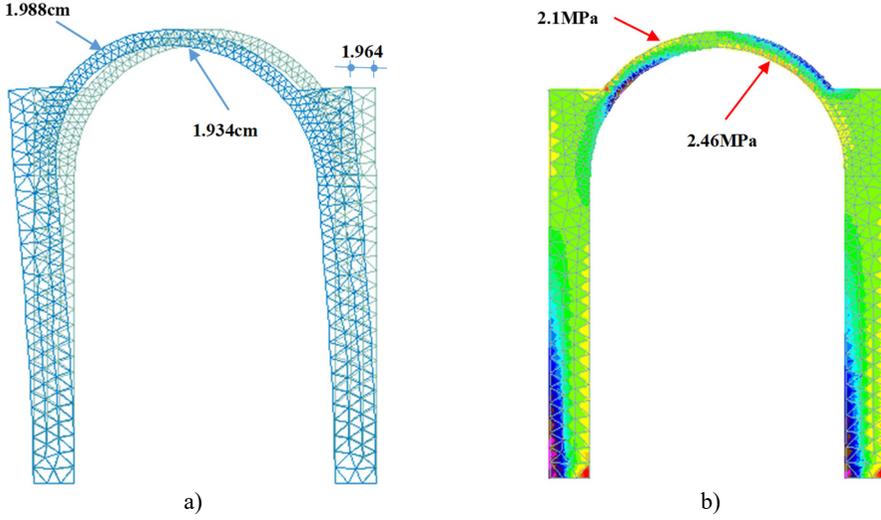
The selfweight condition combined with the seismic forces produces the deformed configuration indicated in the left Fig. 11, in which it can be seen that the point located on the intrados of the nave suffered a lateral elastic displacement of 1.934 cm, and in the zone of the kidneys by the extrados of the vault the lateral displacements reached 1.988 cm. The deformed was again amplified for an ease visualization. The earthquake in fractions of a second changes direction, so the deformed image is reversed and consequently the associated damage. According to the in situ observed cracks, these displacements generated damages to the vault that could be classified as extensive for a relative value equal to 0.0011.

The elastic principal stresses on the extrados of the kidneys of the vault reached 2.1 MPa while

on its intrados reached 2.46 MPa (Fig. 11(b)), values which significantly exceed the almost zero traction resistance for the ancient the masonry. The fundamental vibration period obtained after the calibration process was 0.343 seconds, which practically matches with that provided by the formula [4], and the first four vibration modes obtained are shown in the Fig. 12. Calculated modal participation factors were 66.492 %, 0 %, 16.227 and 0 % for each mode, so it can be notice that de damage zones match with de maximum vault modal amplitudes for the first and third modes.

Fig. 11. Elastic displacements and principal stresses for the selfweight + earthquake load combination

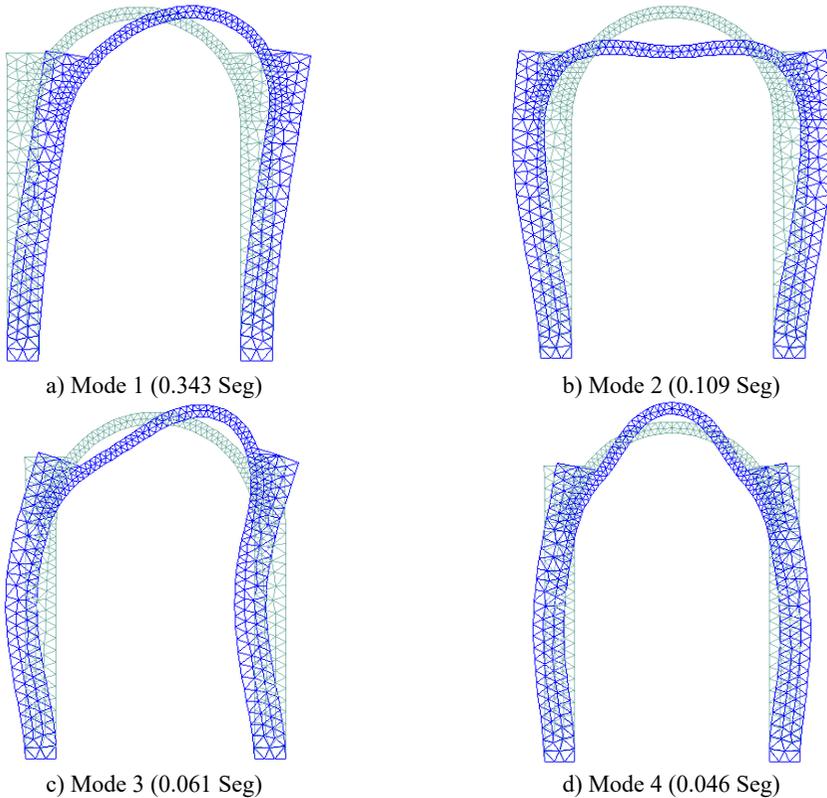
Fig. 12. First four vibration modes

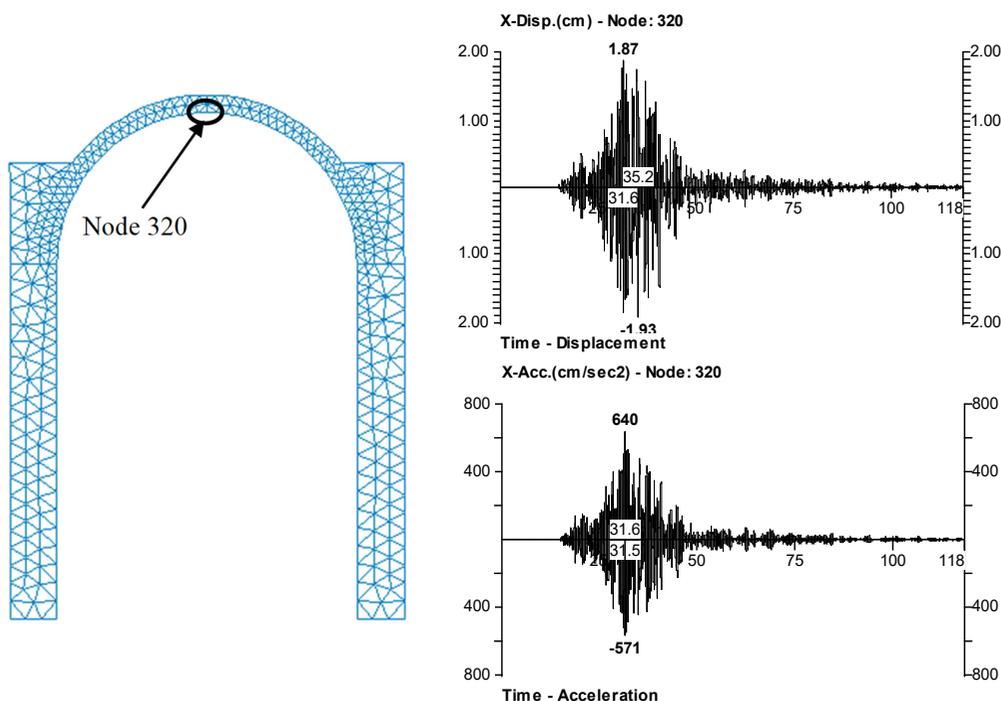
Fig. 13 shows the displacements and accelerations for the center point on the intrados of the key and it is observed that in the second 35.2 the maximum horizontal displacement of 1.934 cm mentioned above was reached, while the maximum acceleration occurs in the second 31.5 reaching a value of 640 cm/s^2 .

Fig. 13. Displacements and accelerations at node 320 of the nave
